Shop No. 1: \$99 Paint-Job Shop

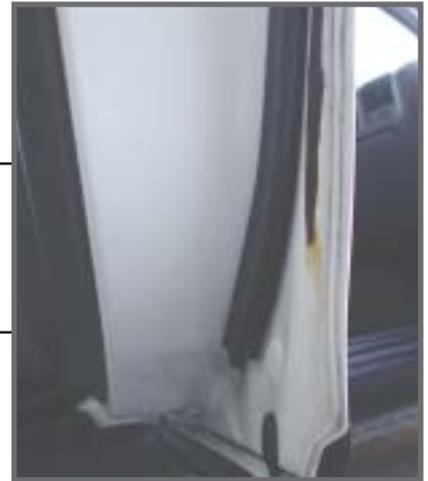
Many estimators tend to overlook damages to the inside of the door, even if the paint is chipped away and the metal is rusting, as is the case here on the rear right door.
