**2009 TL: New Model Body Repair Information**

**DISCLAIMER:** This publication contains a summary of new body and vehicle technology that may affect collision and other body repairs. Always refer to the appropriate service and body repair manuals for complete repair information. A subscription may be purchased at: [techinfo.acura.com](http://techinfo.acura.com)

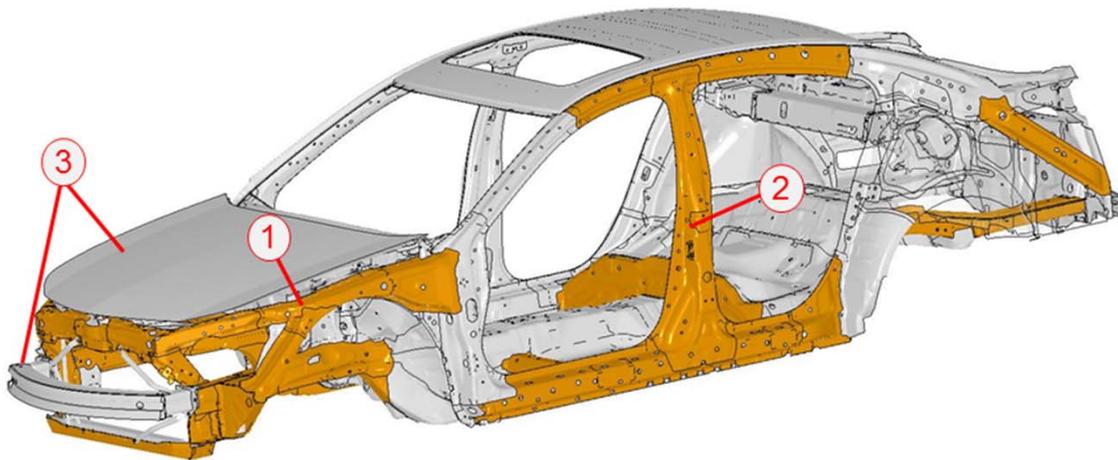
1. Advanced Compatibility Engineering™ (ACE™) body structure.
2. Body construction using 48%+ high tensile strength steel, including 5%+ in grades 980, and 1,500 MPa.
3. Aluminum body components used in key areas for weight reduction and improved fuel efficiency.

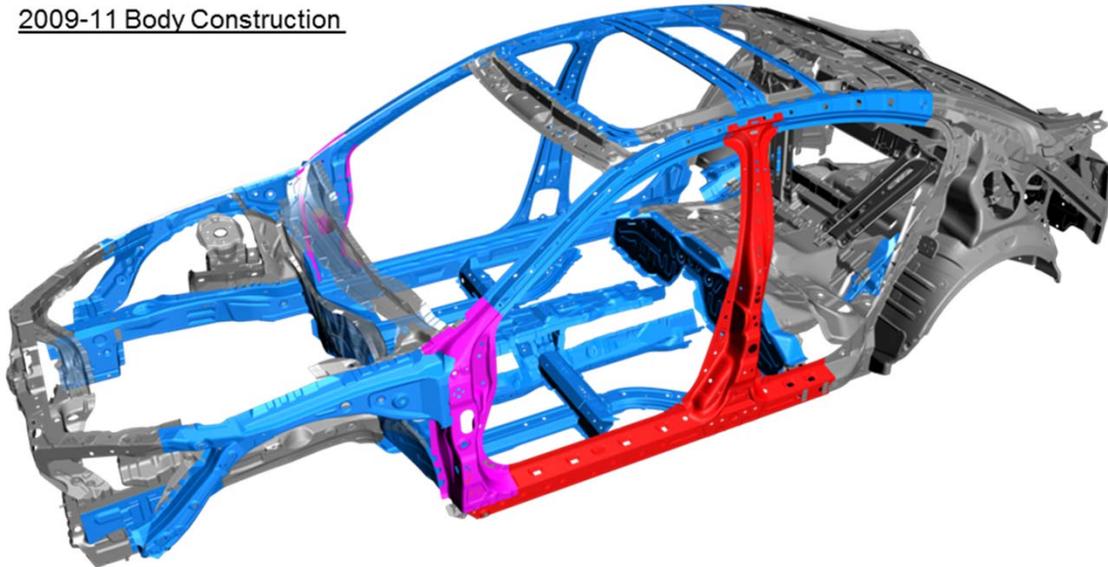
### 2009-11 Body Construction

- Steel parts are color-coded based on their tensile strength in megapascals (MPa).
- High strength steel is defined as any steel with a tensile strength of 340 MPa or higher.
- Steel repair and welding procedures vary depending on the tensile strength of the parts involved.

270 MPa
440 MPa
590 MPa
980 MPa
1,500 MPa

These illustrations are for general reference only. Some body parts are constructed from multiple layers of different tensile strength steels. Always refer to the body repair manual body construction section for specific steel tensile strength information.

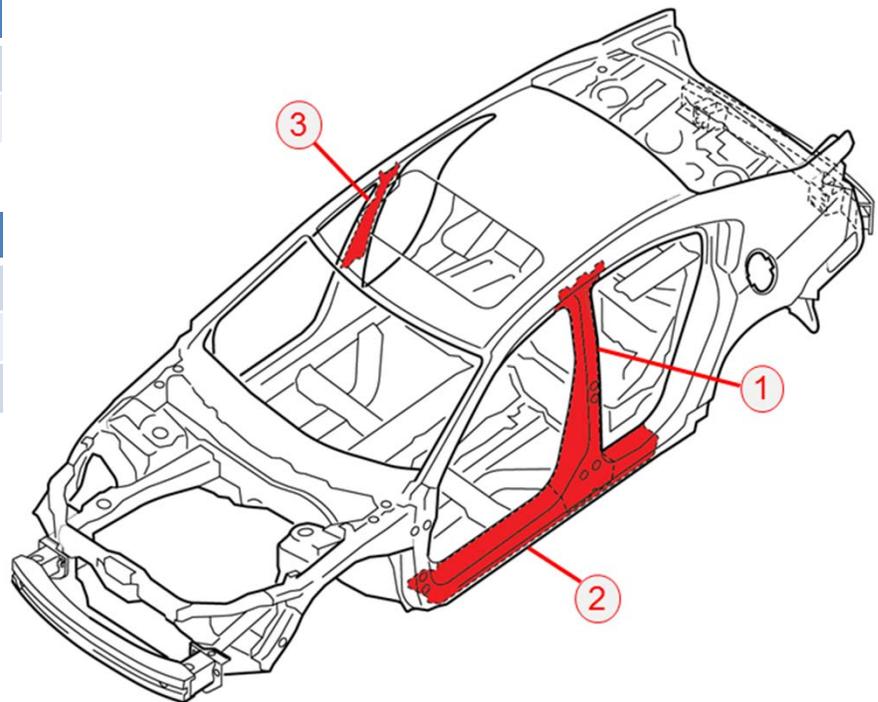
The numbered parts in the diagrams below are constructed of 1,500 MPa steel:

| 1 | Center Pillar Stiffener |
| 2 | Side Sill Reinforcement |

| 1 | Center Pillar Stiffener |
| 2 | Side Sill Reinforcement |
| 3 | Center Pillar Inner Stiffener |

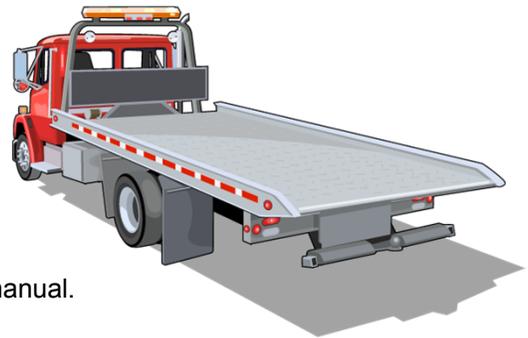
- Lift or jack only at the specified points to avoid damaging the vehicle.
  - Do not lift or tow this vehicle by its bumpers, or serious damage will result.
- For more information, refer to “Lift and Support Points” in the appropriate service or body repair manual.

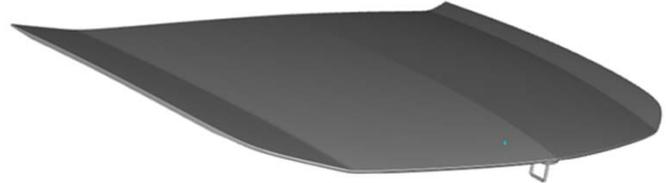
The hood panel and both bumper beams are constructed of aluminum alloy.

- Do not repair the bumper beams if damaged.
- The aluminum hood may be repaired by body shops that have a dedicated aluminum repair facility and separate tools.
- To prevent galvanic corrosion, some fasteners for aluminum parts are considered one-time use and must be replaced if removed. Refer to the service or body repair manual for more information.

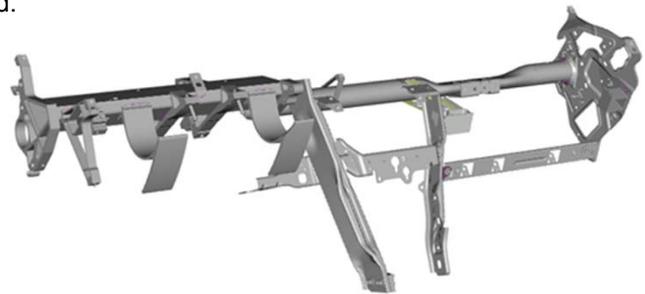
Aluminum Steering Hanger Beam

The steering hanger beam provides mounting for the steering column and dashboard components.

- The beam uses aluminum construction for weight savings.
- Do not repair the steering hanger beam if it is damaged.
- Special threaded collar bolts are used on the passenger side of the beam to compensate for any variation in body dimensions.
- A specific installation and bolt tightening procedure is required.
- Refer to “Dashboard/Steering Hanger Beam Removal and Installation” in the service manual for complete information.

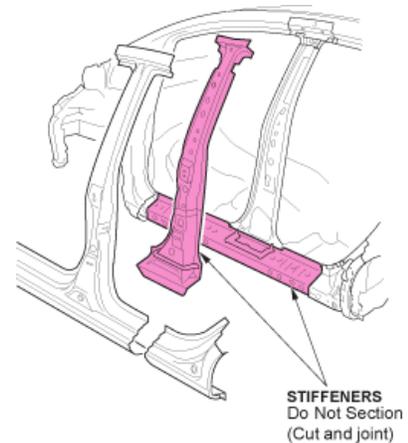
- Avoid sectioning (cut and joint) except for outer panels and floor panels unless a specific procedure is provided in the body repair manual.
- Replace body structural components as assemblies that match the replacement parts configuration.
- Refer to "Front Side Frame and Rear Frame Cutting and Splicing" in the body repair manual for sectioning opportunities.

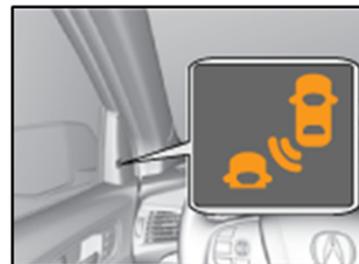
BSI Alert Indicator

Models equipped with this system can be identified by this BSI Alert Indicator, located on both front doors near the outside rearview mirror.

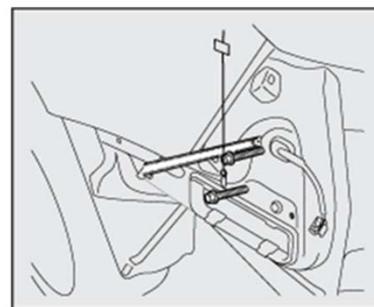
LH BSI Unit Mounting Area Check

- The system uses a radar unit located on each side of the vehicle behind the rear bumper.
- The system may malfunction and set DTCs because of damage, improper repairs, or excessive foreign material on any of the following:
  - Rear bumper
  - Outer side panels
  - Radar unit mounting locations
- Several checks and inspections must be done during repairs to the radar unit mounting area. If the mounting area check is not done, an Acura dealer may not be able to properly aim the radar units.
- For more information, refer to "BSI Radar Unit Mounting Area Check" in the service manual.

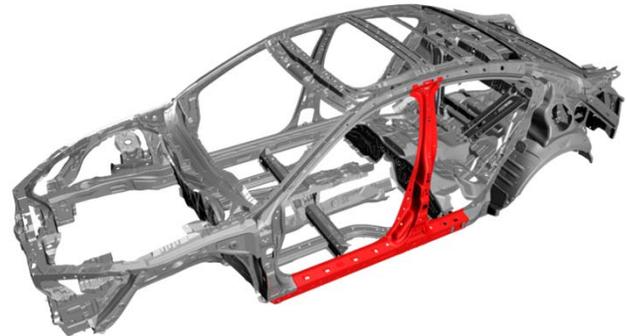
- NEVER attempt to straighten damaged 1,500 MPa steel parts because they may crack.
- 1,500 MPa steel parts MUST be replaced at factory seams using squeeze-type resistance spot welding (STRSW).
- MIG brazed joints should be used ONLY in locations not accessible by a spot welder.
- To assure adequate weld tensile strength, always set the spot welder to the specifications provided in the body repair manual.

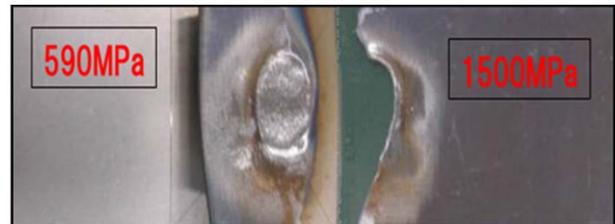
Tensile Test Results of Welded 1,500 MPa Steel

- NEVER perform MAG welding on 1,500 MPa steel. The heat generated during welding will significantly reduce the strength and structural integrity of 1,500 MPa steel parts.
- This photo shows tensile strength test results of welded 1,500 MPa steel. The 1,500 MPa steel fractured first, because the welding heat reduced its strength to far below 590 MPa.
- For more information, refer to “Hot Stamp (1,500 MPa) Parts Welding Specifications” in the body repair manual.

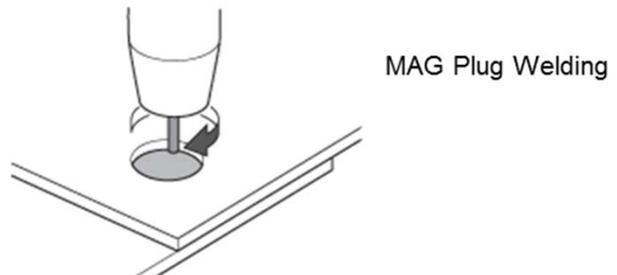
- MAG plug welding may be done when joining body components to 590-980 MPa steel parts.
- Follow the recommendations described in the body repair manual section “MAG welding specifications for high-strength steel parts 590 MPa and higher.”

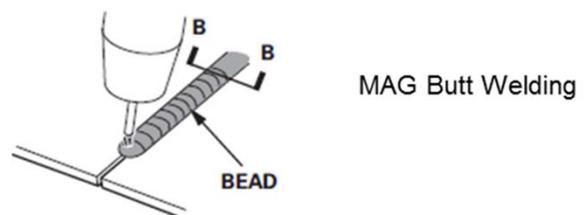
- MAG butt welding may be done only on steel parts with a tensile strength of 590 MPa and lower.
- Welding speed is critical to achieve the correct weld strength and minimize the heat affected zone (HAZ).
- Follow the recommendations described in the body repair manual section “MAG welding specifications for high-strength steel parts 590 MPa and higher.”

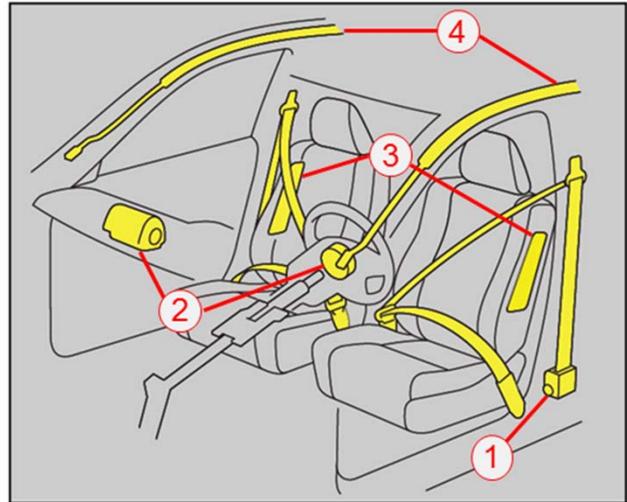
1. Driver and front passenger seat belt tensioners (may deploy independently from any airbags).
2. Driver and front passenger SRS airbags.
3. Side airbags mounted in the outer driver and front passenger seat-backs.
4. Left and right side curtain airbags mounted above the side windows under the headliner.

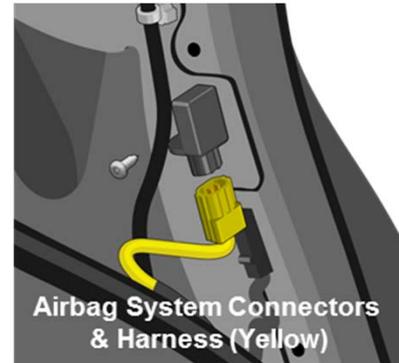
- For easier identification, electrical connectors that contain only airbag system wiring are yellow in color.
- Many harnesses that contain primarily airbag wiring are also wrapped in yellow tape.
- Airbag system wiring that runs in a common harness, such as a floor harness, is generally not marked.
- NEVER attempt to modify, splice, or repair airbag system wiring.

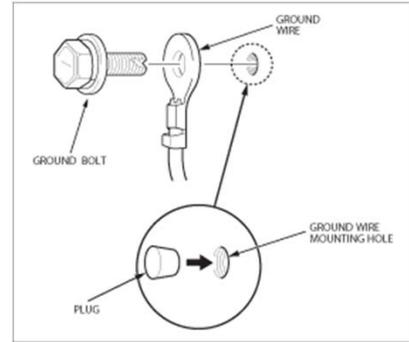
- Painting over electrical ground locations may cause electrical systems, such as Vehicle Stability Assist (VSA), to malfunction and set DTCs that may be difficult to diagnose.
- Protect the ground wire and the ground wire mounting hole threads with a bolt or plug when priming or painting.
